# WORCESTER PARK SECTION 19 FLOOD INVESTIGATION

PREPARED FOR LONDON BOROUGH OF SUTTON

Authored by Natalie Seeger  
Reviewed by: Darragh Creegan  
Approved by Mike Mair  
Date August 2022  
Version 3.0

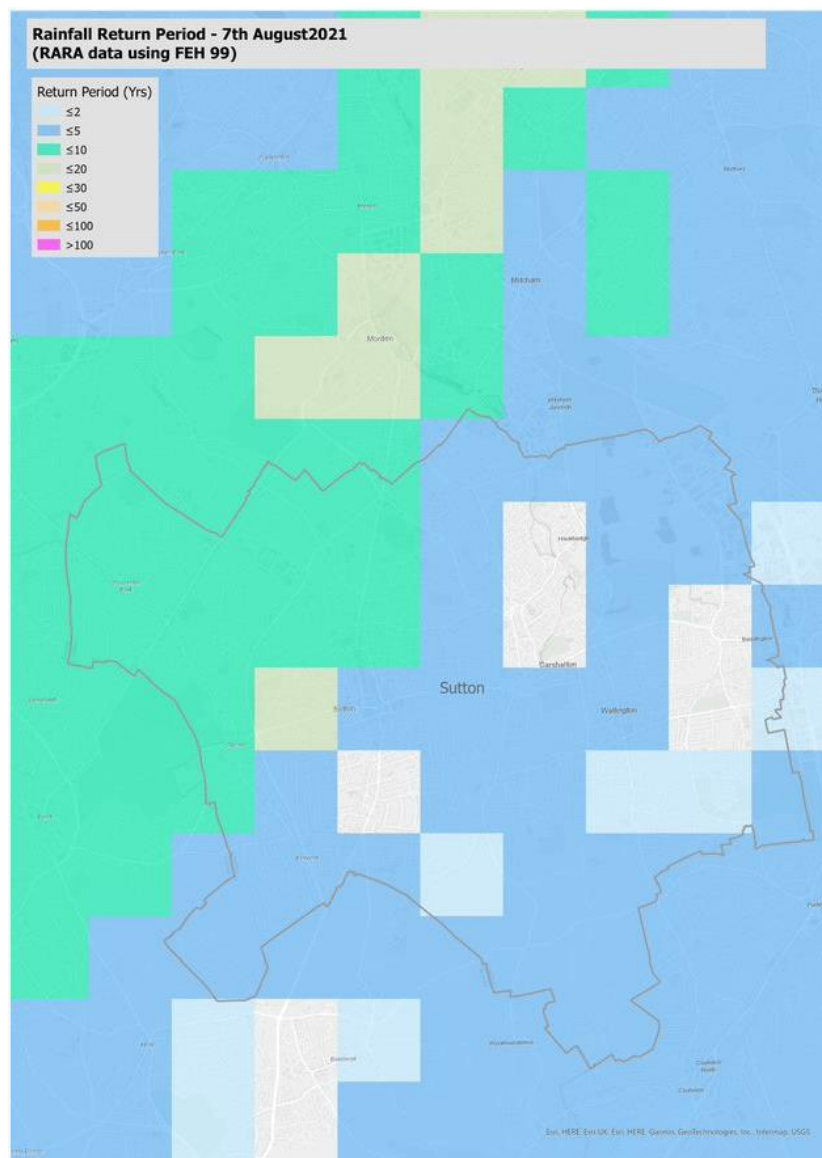
Figure 3-3: Rainfall return period for the 7<sup>th</sup> August (RARA data using FEH 99) (TWUL, 2022)

On the 7<sup>th</sup> August another rainfall event occurred and led to five reports of internal flooding, and one where the specific location of flooding is unconfirmed. There were no known traffic disruptions in the area on this date. TWUL attended Oaks Avenue to check the foul and surface water sewers on this date due to reports of flooding. Rainfall return period data was produced by TWUL for the event (*Figure 3-3*). This shows that the return period for the entire Worcester Park on this date was a 1 in 10 year event. This is lower than previous events however flooding was still experienced on this date.

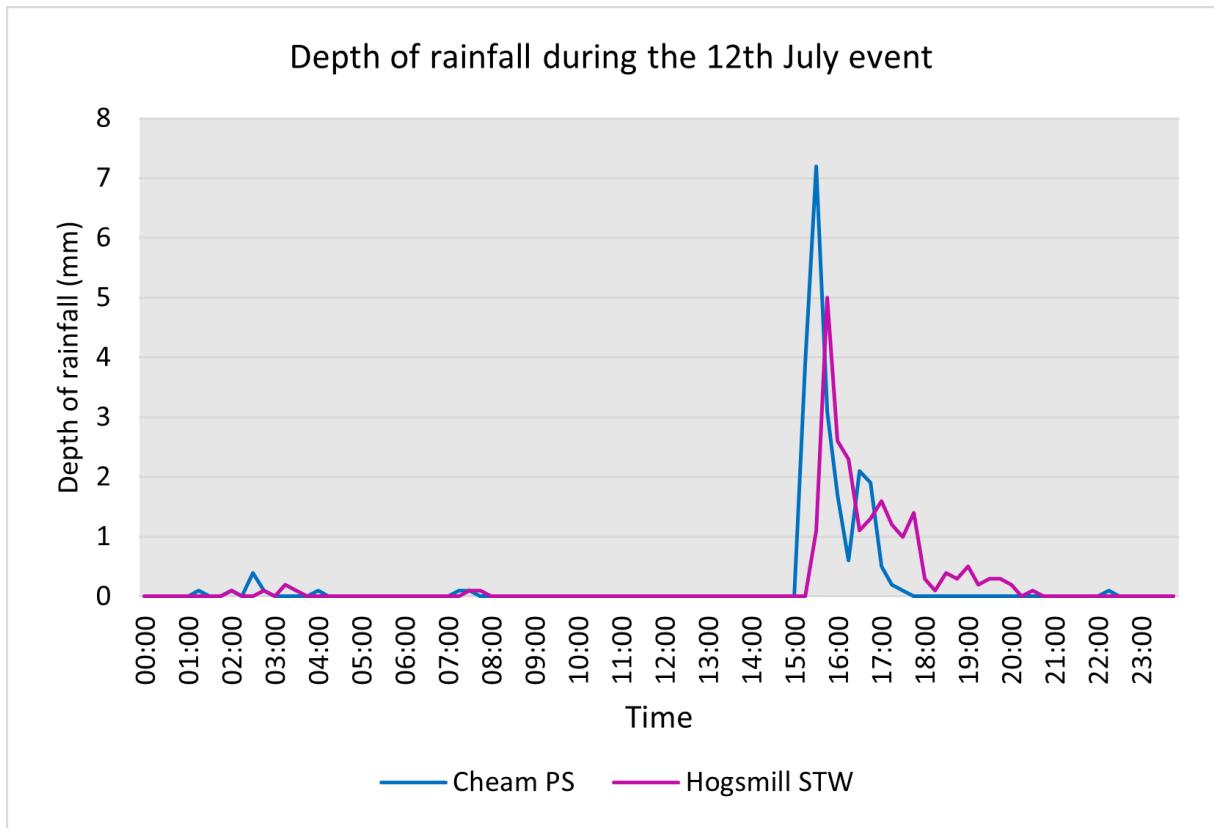
**Figure 3-6: Depth of rainfall during the 12<sup>th</sup> July event**

Each rainfall event experienced different peak times and amounts. For both July events, rainfall peaked within one hour in the afternoon (*Figure 3-6* and *Figure 3-5*). For the 7<sup>th</sup> August, the rainfall continued over a period of 4 hours during the morning (*Figure 3-7*), and for the 20<sup>th</sup> October there was one peak recorded by the Hogsmill STW rain gauge at midday and further peaks of rainfall were recorded during the evening by both rain gauges (*Figure 3-8*). Based on the information provided, the peak rainfall is not as high as expected given the nature of these events, particularly for the 12<sup>th</sup> and 25<sup>th</sup> July. The [London Flood Review](#) which was written following the flooding events of the 12<sup>th</sup> July and 25<sup>th</sup> July states that severe flooding occurred across London on these dates, and the flooding witnessed in Worcester Park reflects this. It is likely that the data may not fully describe the events that occurred in Worcester Park given the distance of the rain gauges away from the hydrological catchment area. The rainfall experienced on these dates may have been more localised and given that there are no rain gauges within the hydrological catchment area, it is difficult to provide an accurate representation for peak amounts of rainfall within Worcester Park.

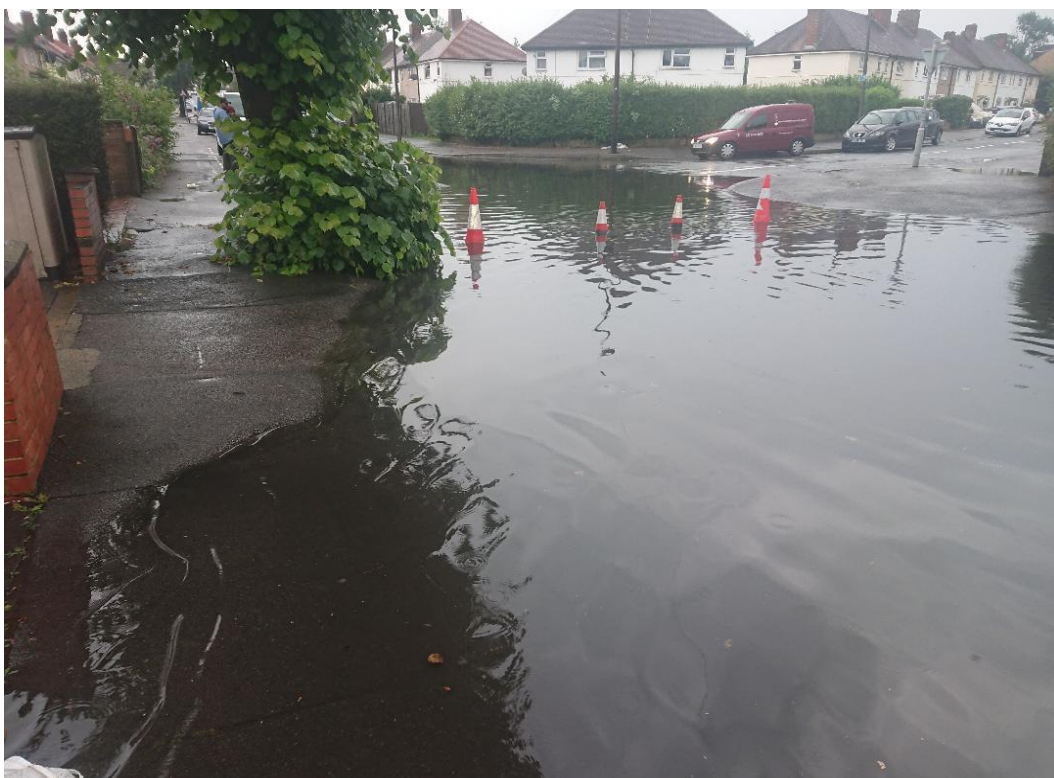
Figure 4-1: Flooding on Browning Avenue on the 12<sup>th</sup> July. Source: LB Sutton

It is possible that the surface water sewer system in Browning Avenue was overwhelmed by rainwater or blocked as TWUL attended the road on the 12<sup>th</sup> July to clear the surface water sewer. TWUL attended Browning Avenue multiple times during 2021 and once during 2022 to clear blockages in a specific stretch of the foul water sewer due to sewer misuse (wet wipes, thick rag and concrete). There is only one gully located at the junction of Washington Road and Browning Avenue, which may not have allowed sufficient drainage into the sewer during this event (*Figure 4-3*). A review of the EA's Risk of Flooding from Surface Water (RoFSW) data shows that the area which experienced flooding on Browning Avenue is at risk from the 1 in 30, 1 in 100, and 1 in 1000 year events (*Figure 4-2*). *Figure 4-1* shows water pooling on the surface of the road. This suggests that the corner where Browning Avenue intersects with Washington Road is likely to be at a topographical low point, where surface water has accumulated as it has nowhere to drain to. They may be due to either a blocked sewer or a lack of drainage assets. This area is therefore at high risk from surface water flooding.

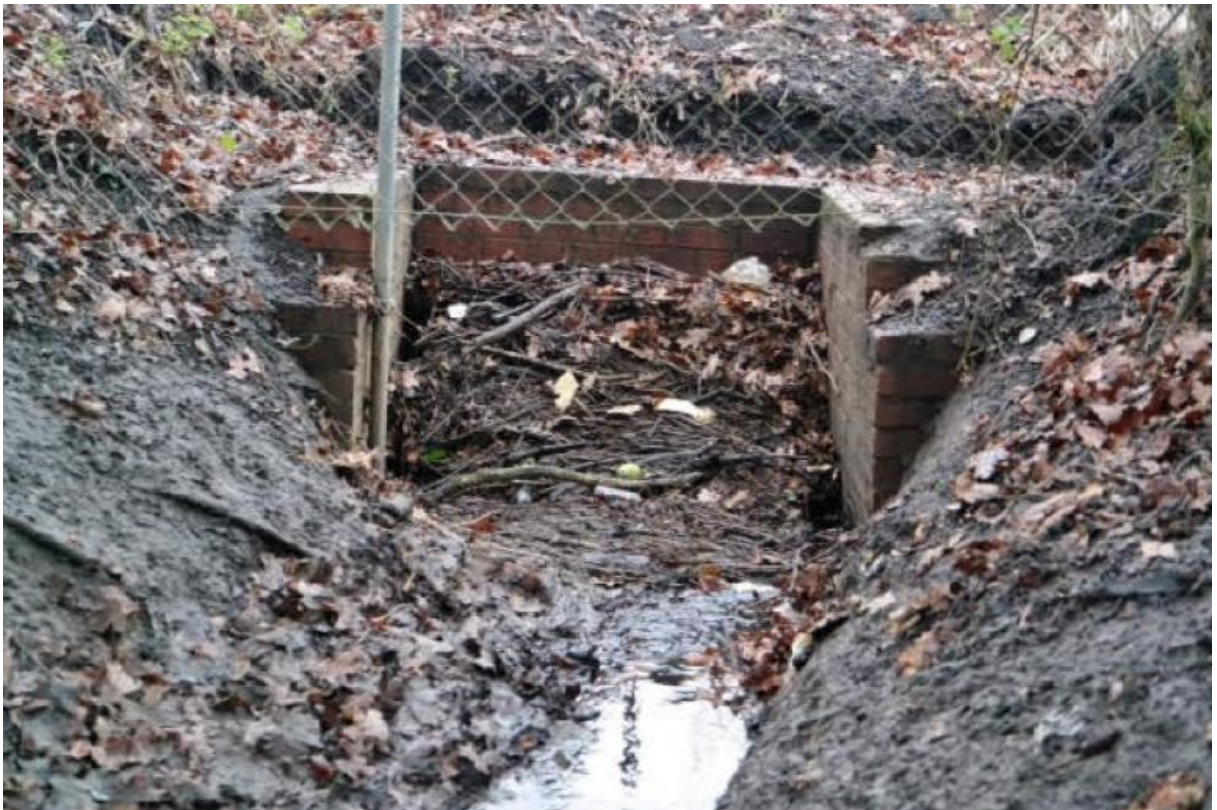
In Worcester Park, water predominantly flows in a northerly direction towards the Beverley Brook. The flooded properties on Caldbeck Avenue, Longfellow Road, Brinkley Road, and Lindsay Road, lie on a topographical low point within the catchment area. Surface water is conveyed towards the mid-point of these roads before moving northwest towards Green Lane and the Beverley Brook. Cuddington Recreation Ground is situated on a slope and surface water is conveyed downhill and then along Sandringham Road. Residents on Sandringham Road reported that the flooding had likely taken place due to the Beverley Brook trash screen on Cuddington Recreation Ground being blocked (*Figure 4-6*) as water was flowing out from the park onto the road.

**Figure 4-6 The blocked culvert entrance on Cuddington recreation ground. Source: Resident**

The most likely causes of the flooding experienced in Worcester Park on the 25<sup>th</sup> July 2021 has been investigated. The heavy rainfall from this event led to an inundation of water in the area. One of the main sources of flooding was surface water flooding, where water accumulated on the roads and was unable to drain away via the drainage system. The sewers were surcharging into the road at several locations suggesting that they were unable to accommodate this volume of water. At some locations the sewers were blocked by grass cuttings and debris, as reported by residents and TWUL, exacerbating this problem. Furthermore, the water levels in the Beverley Brook were very high, suggesting that the outfalls from the sewers into the Beverley Brook were submerged. This meant that there was no capacity to take on the water from the sewer system. Since water was unable to drain to the river through the sewer system, water pooled against the flood wall along the Beverly Brook on Green Lane. The presence of the flood wall prevented the Beverley Brook from bursting its banks, so it was not likely a cause of flooding. However, it may have prevented water draining away after the flooding event. There is potential for there to have been groundwater flooding on Oaks Avenue, which was also previously suggested in the Section 19 Borough Wide report for LB Sutton (2017). This may have been caused by the 12<sup>th</sup> July 2021 event increasing the groundwater table. Lastly, the trash screen in Cuddington Recreation Ground was blocked during this event which led to water flowing out across the park and onto Sandringham Road, increasing the volume of flooding experienced there.
