SUTTON – BOROUGH WIDE (2017)
FLOOD RISK INVESTIGATION

PREPARED FOR LONDON BOROUGH OF SUTTON

Created by Elijah Salami
Reviewed by Damon Reid-Williams
Approved by Michael Mair
Date December 2020
Version 1.2

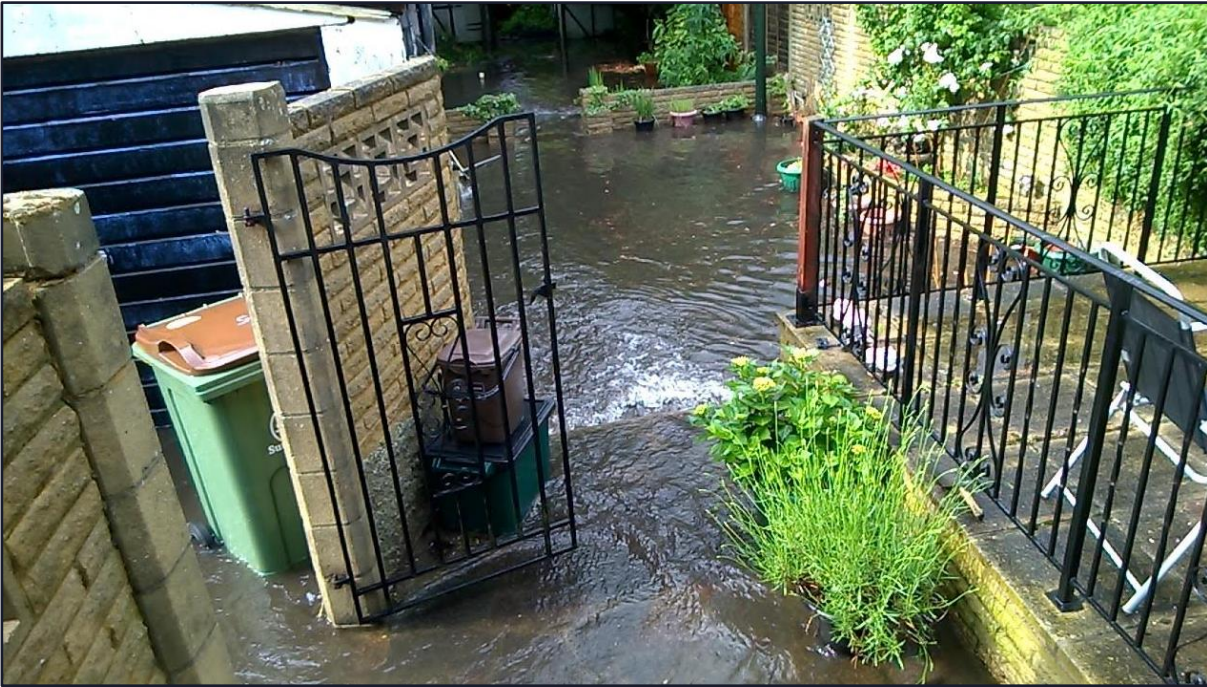
Figure 2-1. Flood water entering the front of property at Osmond Garden - © Resident, 2017

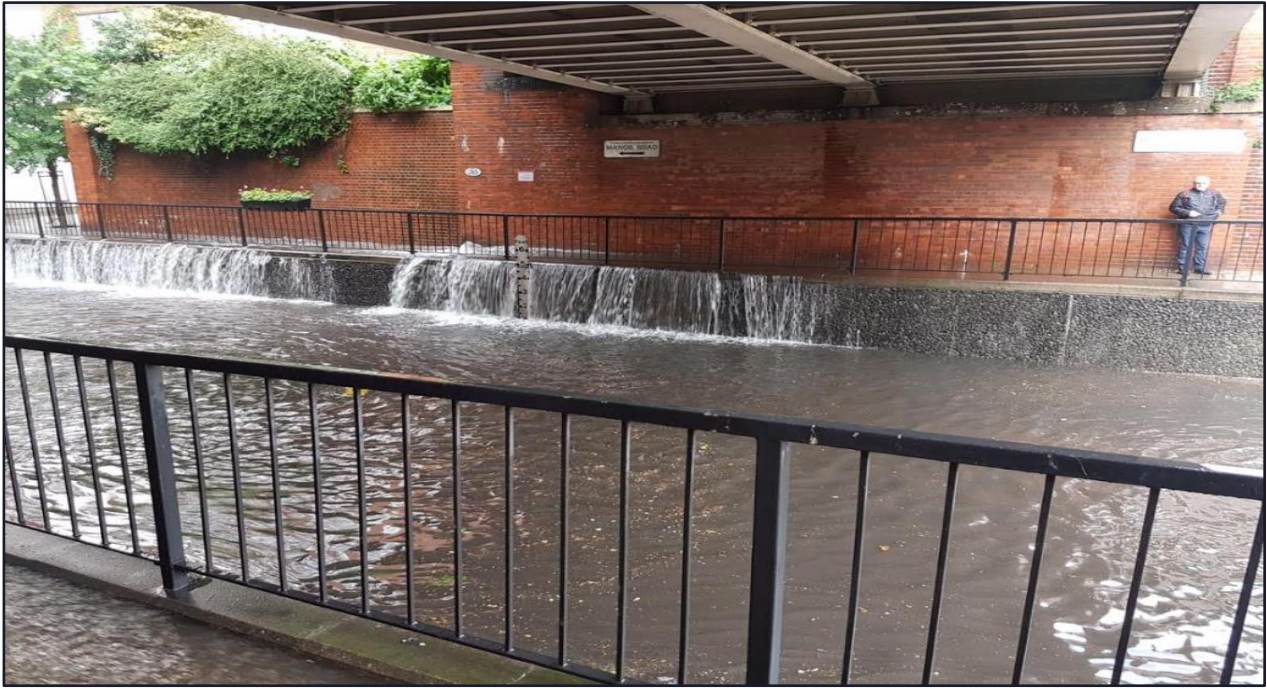
Figure 2-3. Water surcharging from manhole on the footway which resulted in flooding of the highway underneath Wallington Bridge - © Resident, 2017

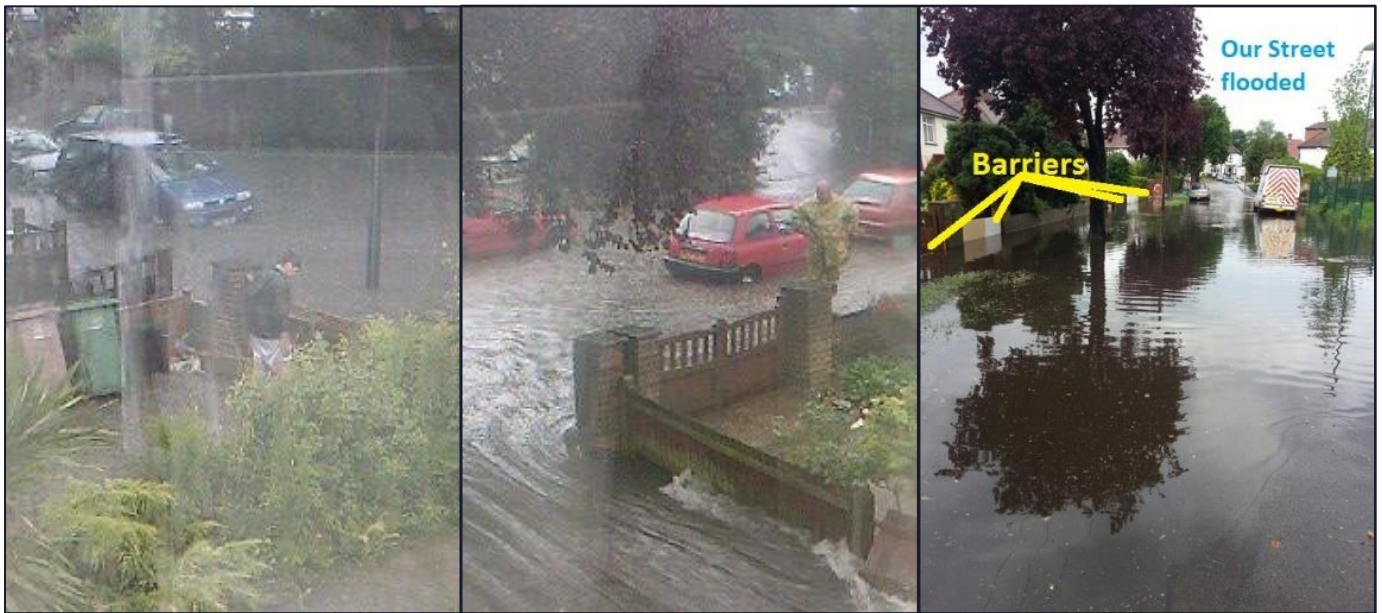
Figure 2-4 Flooding across properties along Beddington Gardens - © Resident, 2017

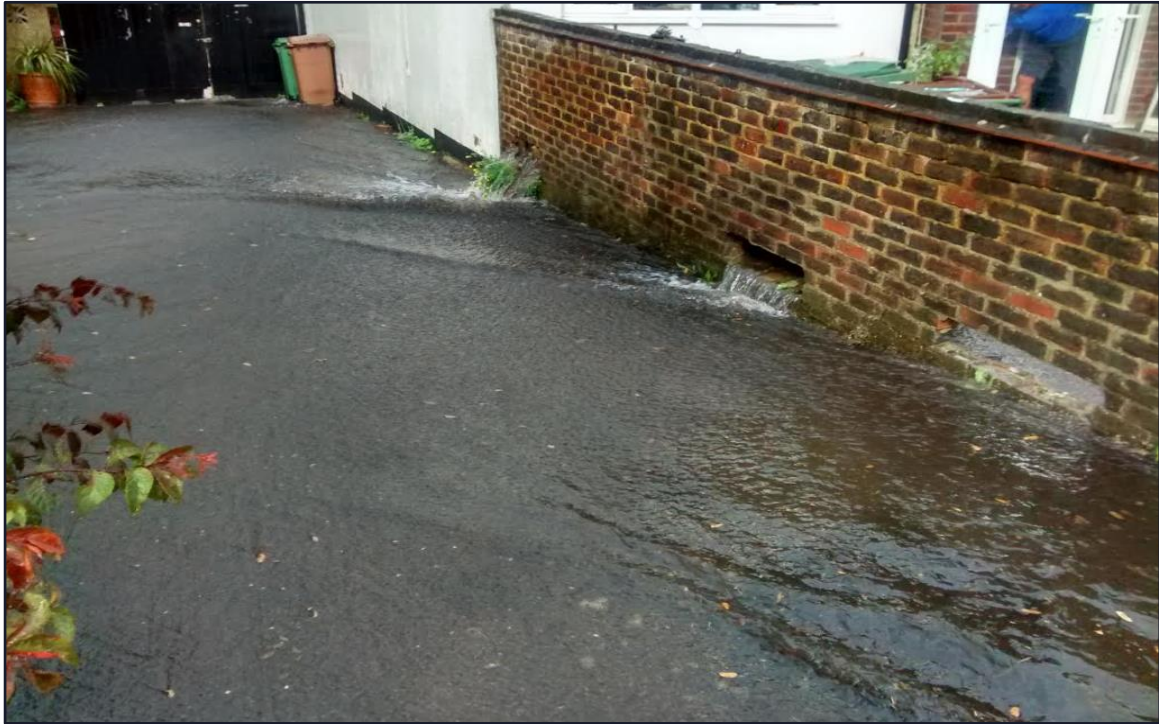
Figure 2-5 Flood water entering property on Northwood Road - © Resident, 2017

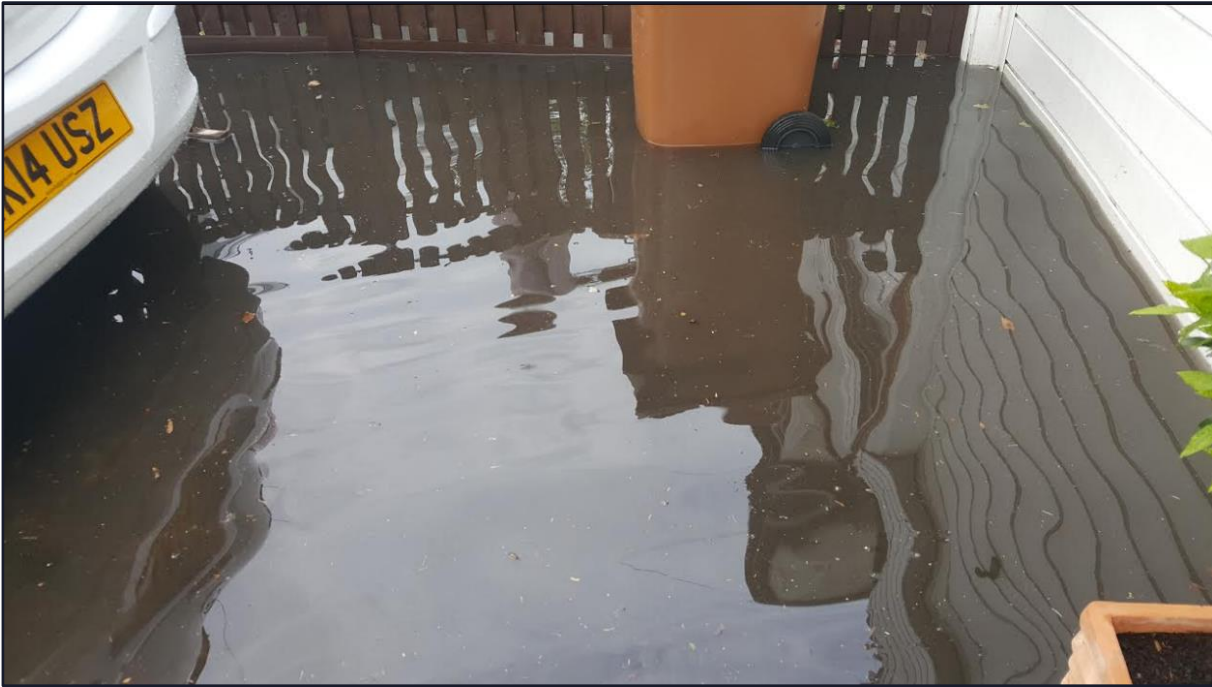
Figure 2-7. Flooding at property on Nightingale Road - © Resident, 2017

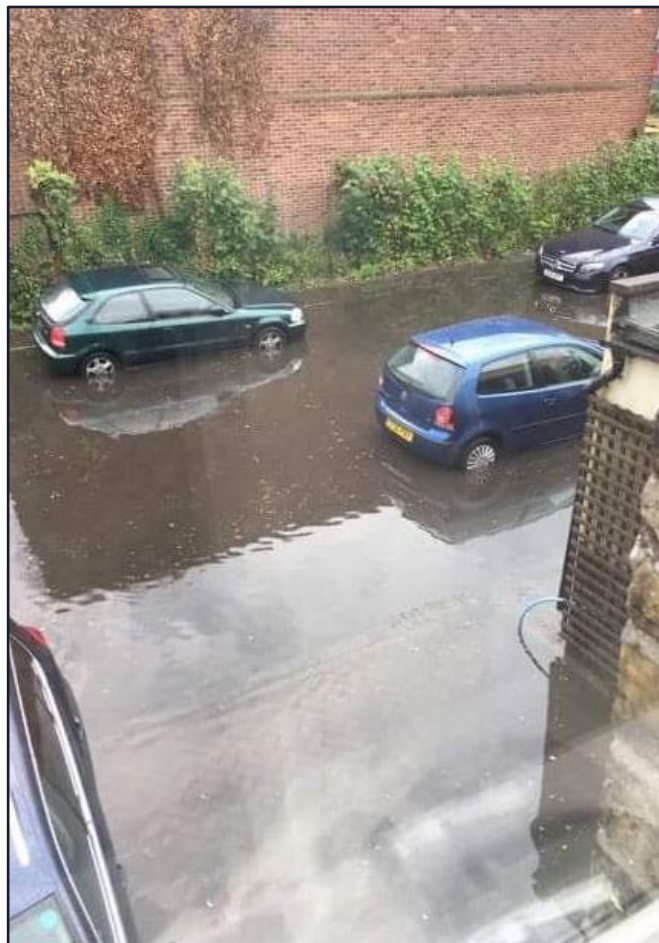
Figure 2-8. Flooding at Carshalton Grove - © Resident, 2017

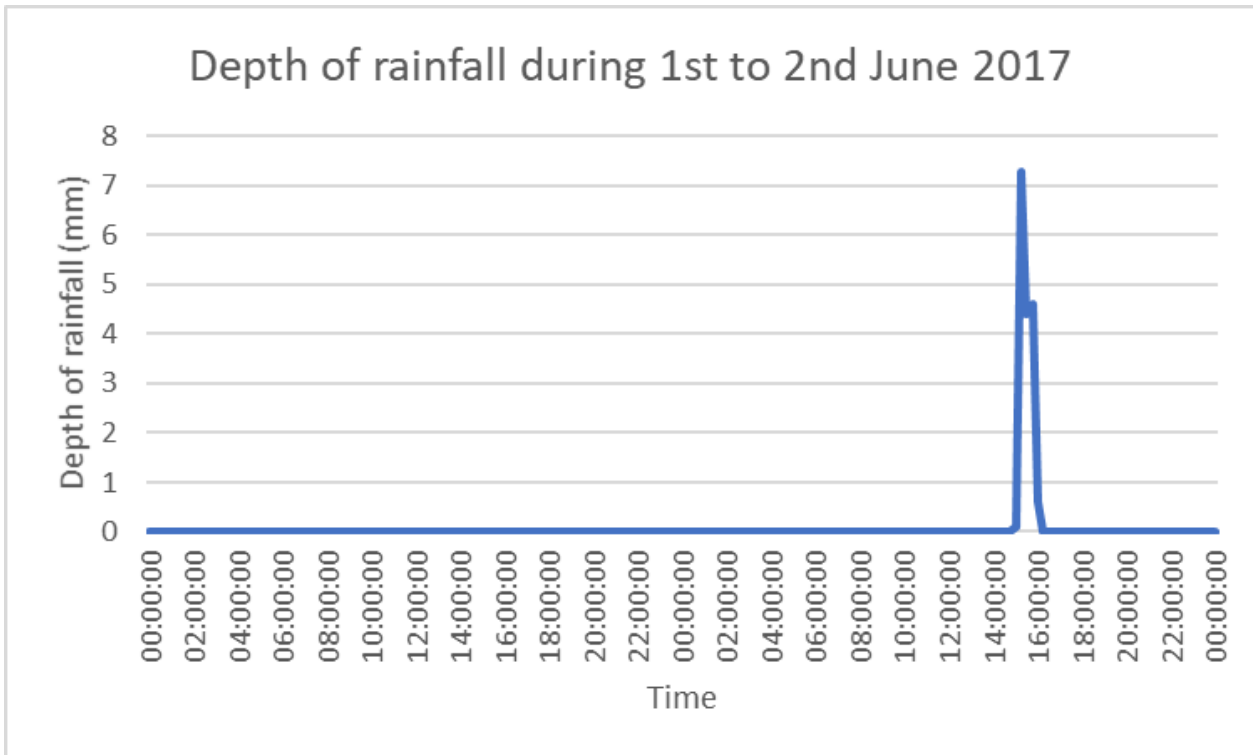
Figure 3-5. Depth of rainfall for June 2017 event (How Green Reservoir)

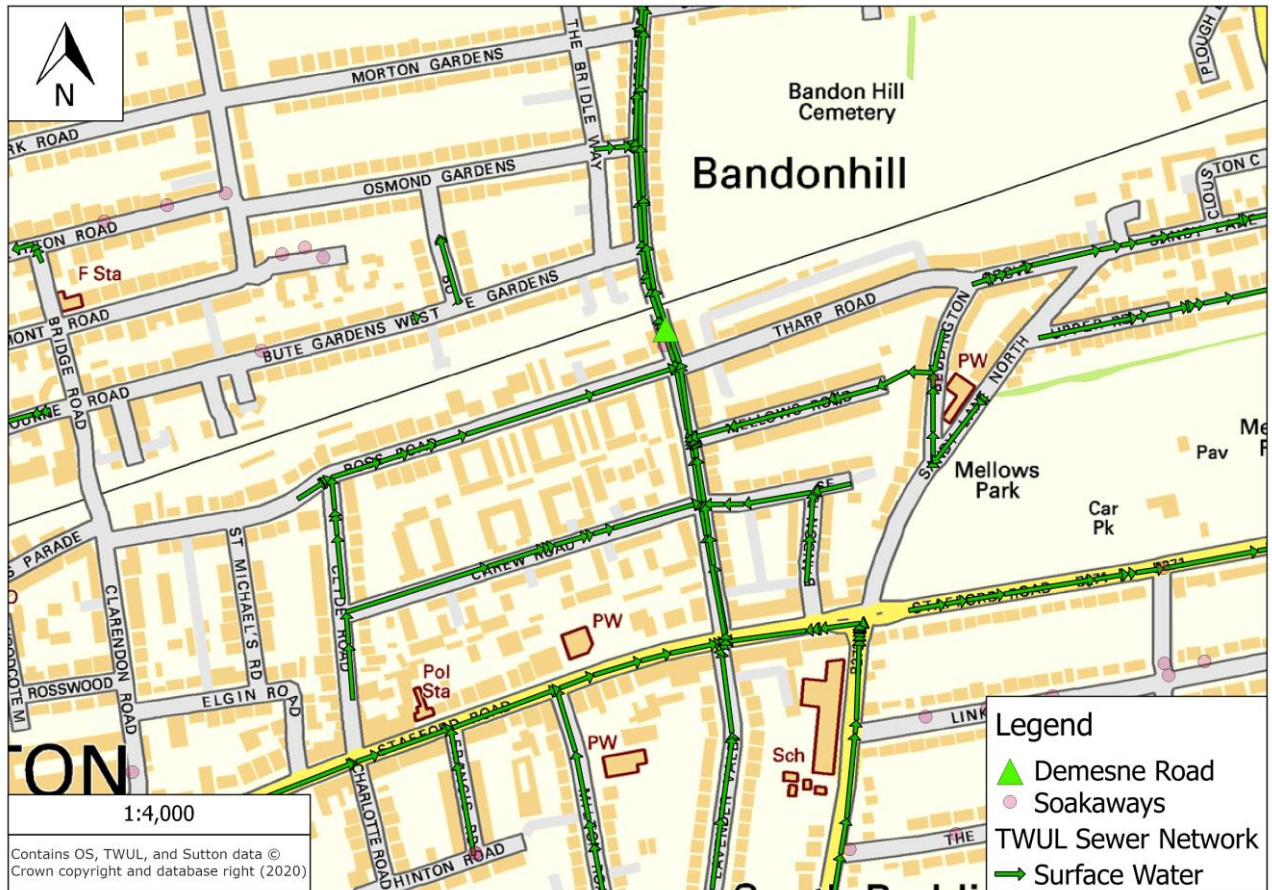
Figure 5-2. Surface water sewer network and soakaways – Demesne Road

There are surface water sewers on both sides of Demesne Road. One surface water sewer network flow in a northerly direction from the south of Demesne Road (starting from Stafford Road), with interchanging diameters of 450mm and 600mm before discharging into a 600mm diameter surface water sewer at the junction with Croydon Road. The 600mm diameter surface water sewer runs from Croydon Road onto the adjacent Church Road and continues to flow in a north westerly direction. The 600mm section finally discharges into the River Wandle approximately 1.2km north of the sites along Demesne Road. The second surface water sewer network is a 450mm diameter pipe which flows in a northerly direction from the south of Demesne Road. The surface water sewer is diverted onto Montague Road then diverted onto Rectory Lane. The surface water sewer continues to flow along Rectory Lane in a northerly direction and discharges into a 600mm diameter surface water sewer at the junction with Croydon Road. The surface water sewer continues to flow in a north western direction before discharging into the River Wandle approximately 1.3km north west of the sites along Demesne Road. There is also a separate foul sewer network, flowing from south to north. The diameter of the foul water pipe along Demesne Road is 300mm.

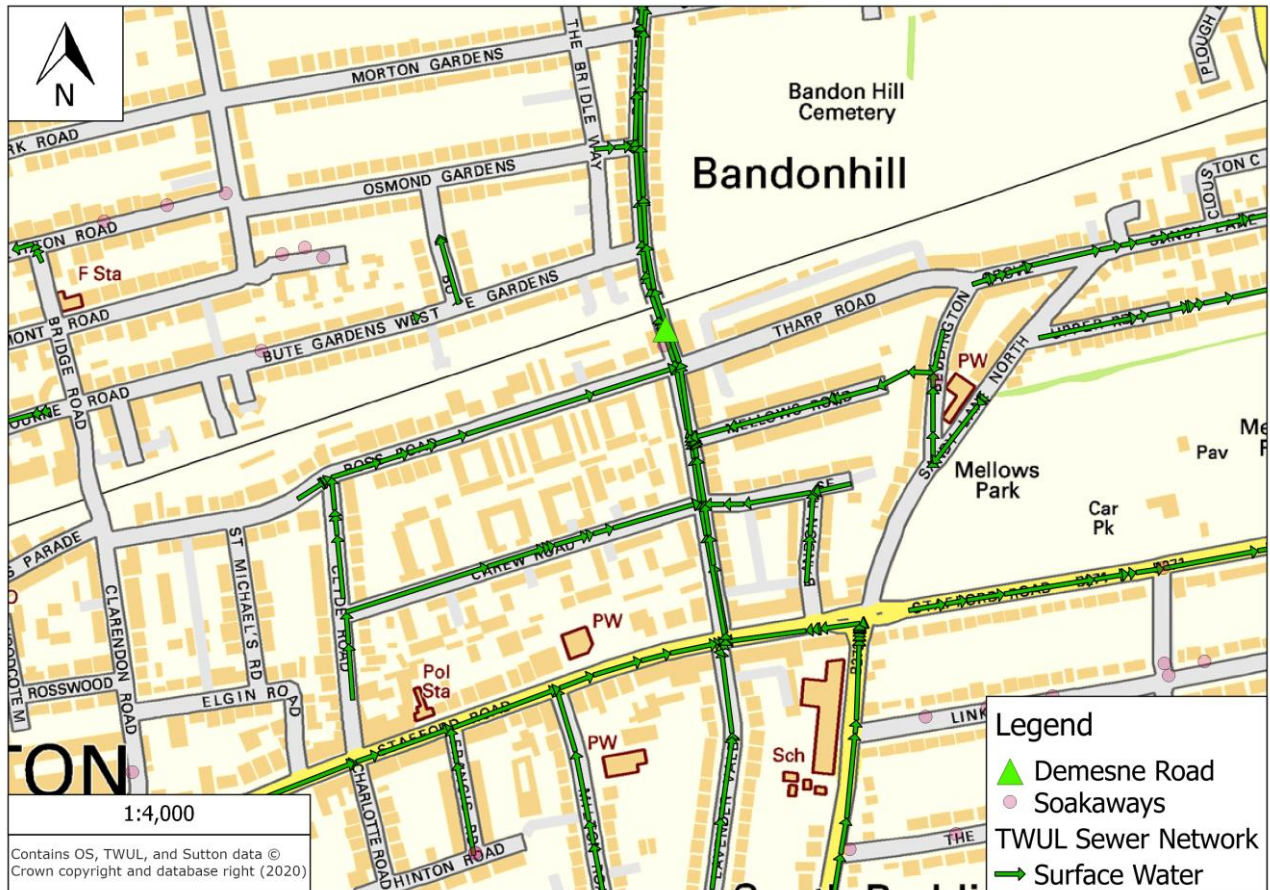
There are numerous soakaways within the vicinity of Demesne Road. The nearest soakaway is located at the junction between Ross Road and Demesne Road. The soakaway has been labelled as being in ‘poor’ condition. This suggests the soakaway may not be as effective as it could be at discharging surface water via infiltration into the underlying chalk geology. Further information on the location of soakaways in the local area are shown in *Figure 5-4*.

- Sutton and TWUL to collaborate to keep undertaking regular maintenance of the gullies and sewer networks to avoid blockages.
- Sutton to investigate the soakaway on Ross Road to determine its condition and if maintenance or a repair of the asset is required.

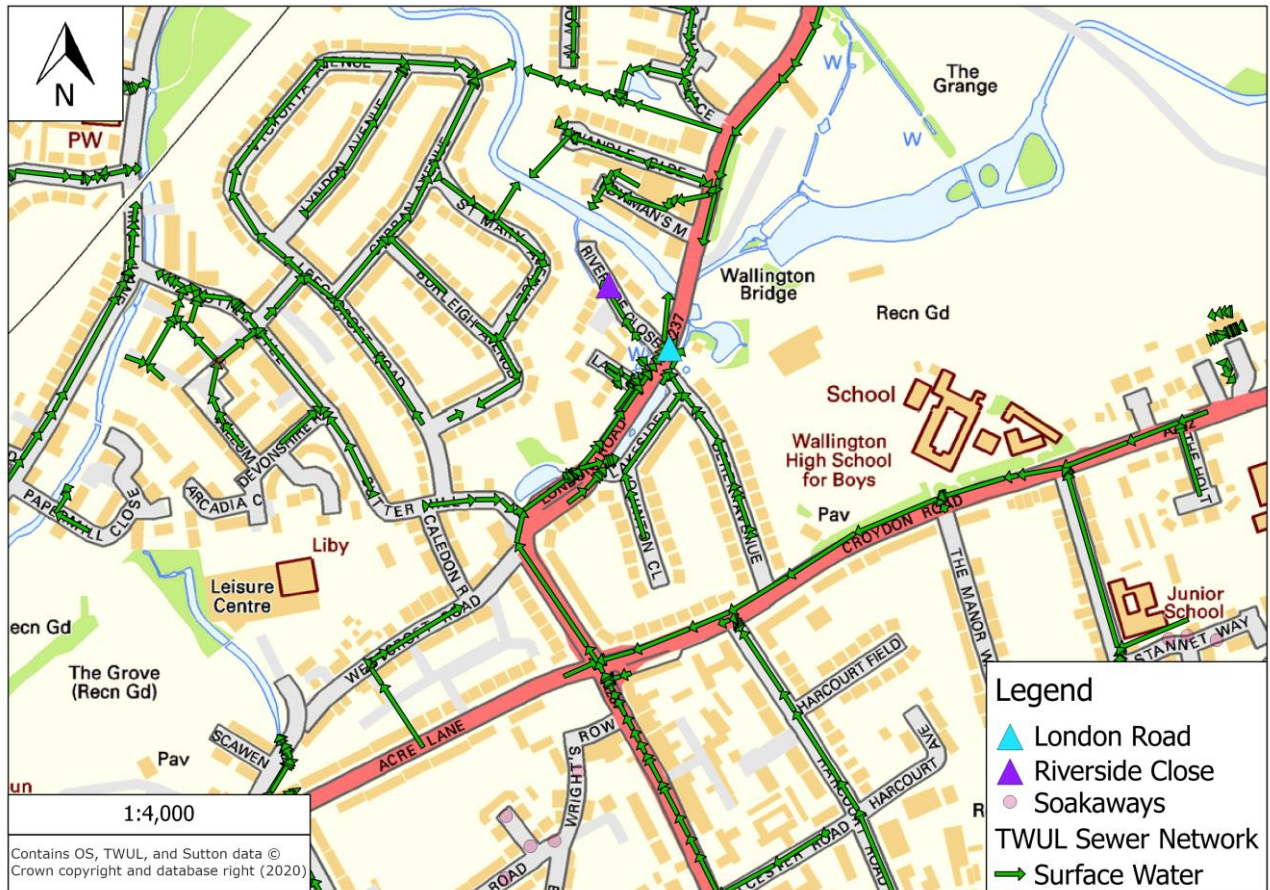
There are numerous soakaways in the wider vicinity of London Road and Riverside Close. The nearest is a 2.5m deep concrete lined soakaway located by Vellum Drive, approximately 360m north west of both roads. The soakaway has been labelled as being in ‘good’ condition. This is shown in *Figure 6-2*.

Figure 6-2. Surface water sewer network and soakaways – London Road and Riverside Close

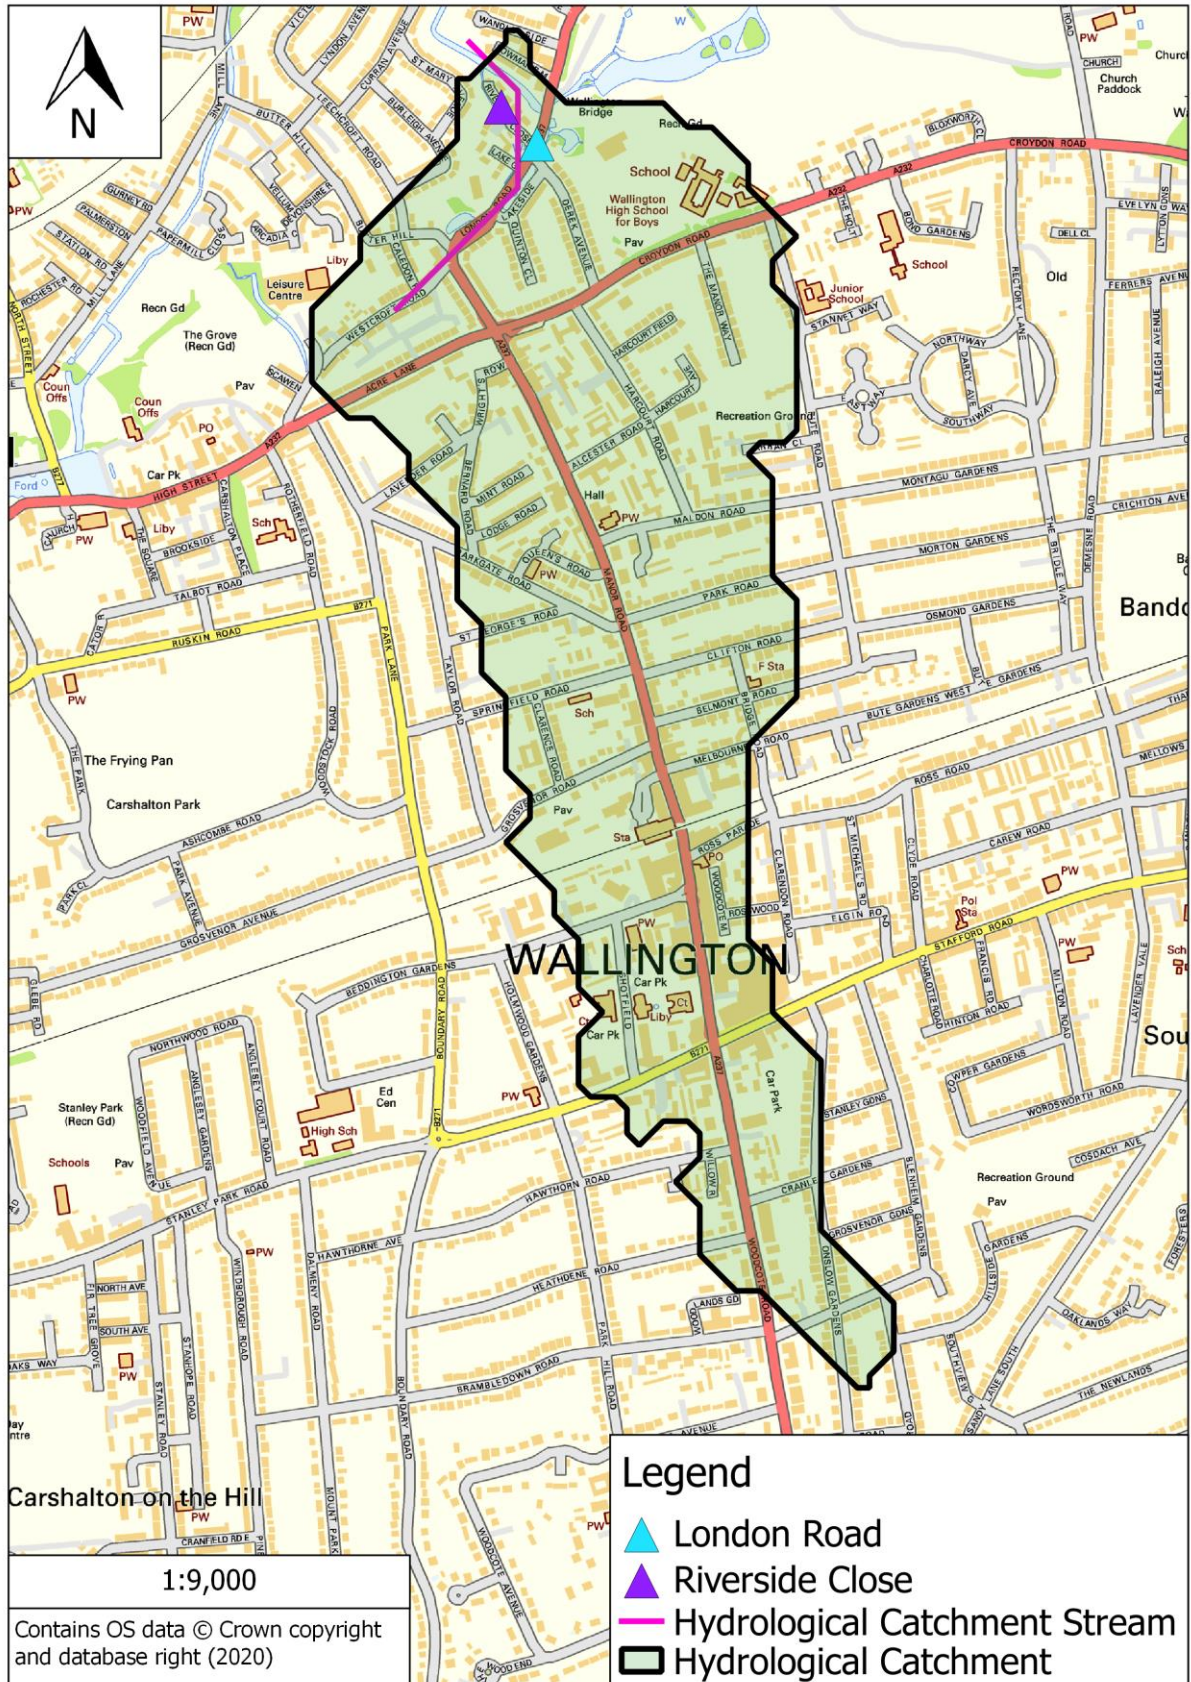
Figure 6-3. Hydrological catchment and catchment stream – London Road and Riverside Close

Analysis of the area using a GIS provided several outputs, including defined hydrological catchments and primary flow paths (shown as ‘Hydrological Catchment Stream’ in *Figure 6-3*). LiDAR data shows that Riverside Close lies within a topographical low point within the hydrological catchment. This means that surface water within the defined catchment will naturally drain along London Road and towards Riverside Close. Therefore, the properties along Riverside Close are considered to be located within a flood hotspot. The primary flow paths are the main overland flow route for surface water in the defined catchment. The main overland flow route for the catchment area flows in a northerly direction towards Riverside Close. The overland flow path then outfalls into the River Wandle just north of River Side Close.

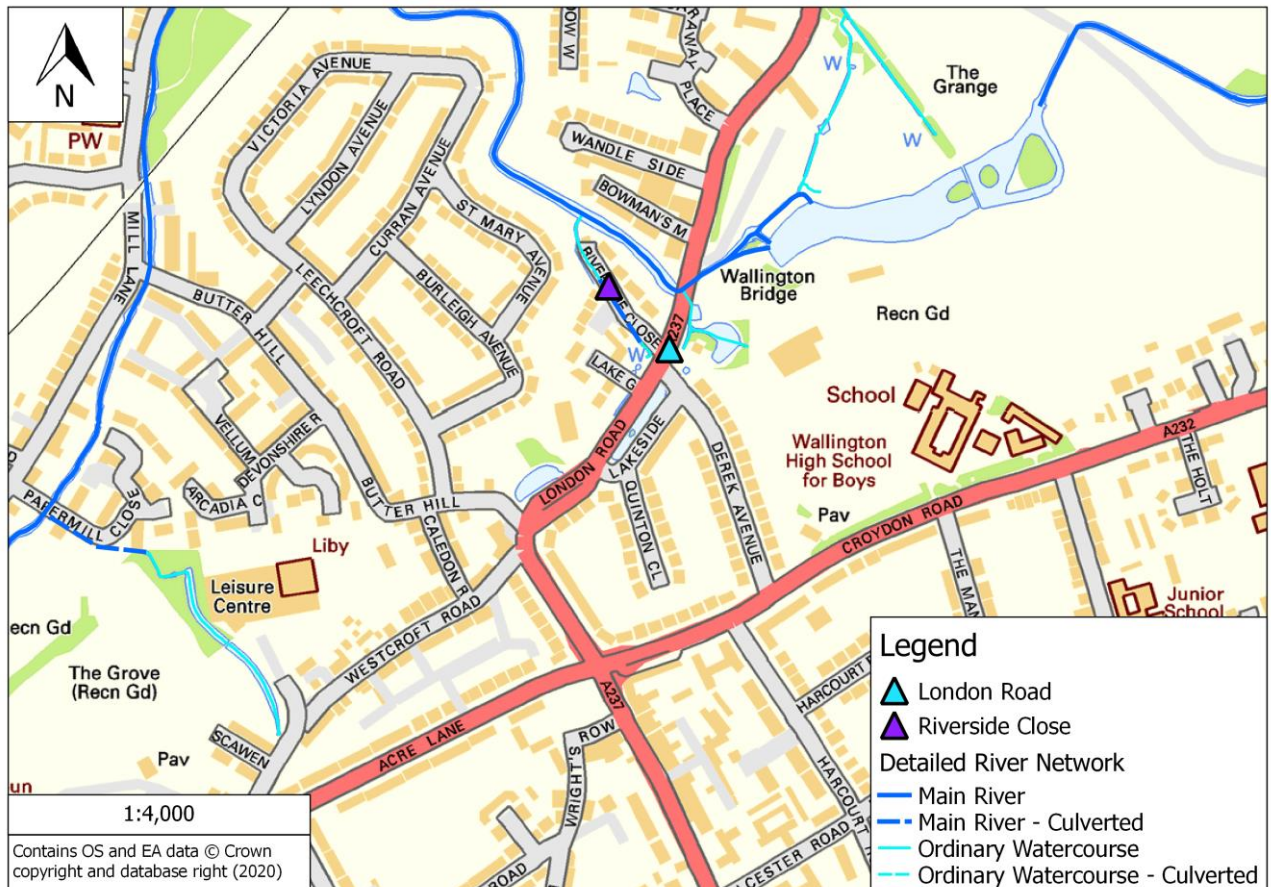
Figure 6-5. Detailed River Network – London Road and Riverside Close

There are ordinary watercourses which serve as tributaries of the River Wandle that fall within the hydrological catchment (see *Figure 6-5*). A review of the EA Detailed River Network data confirms that there is an ordinary watercourse which lies approximately 11m north of the impacted property on London Road. The ordinary watercourse is a tributary of the River Wandle and flows in a north westerly

direction before discharging into the River Wandle, approximately 40m north west of the impacted property on London Road. A review of the EA RoFSW map shows that water is predicted to overtop the ordinary watercourse’s banks during the during the 1 in 1000 year event. This flood source is predicted to partially flow in a southern direction before encroaching onto the impacted property on London Road. There is also a minor ordinary watercourse which connects to the TWUL surface water sewer network alongside Riverside Close approximately 80m south west of the site. Based on this information, both sites are at risk from flooding ordinary watercourses.

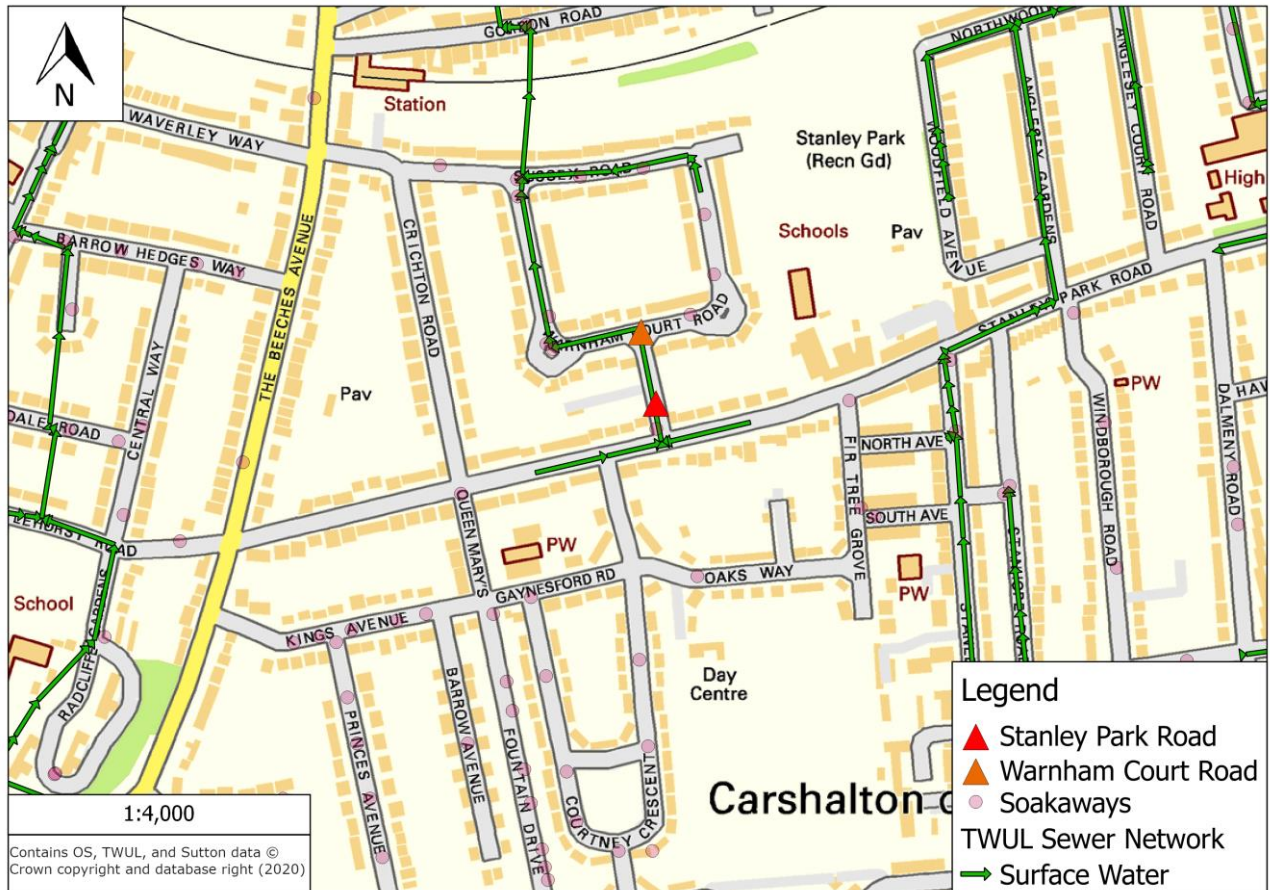
There are also multiple soakaways in the local area due to the underlying chalk geology. Nine soakaways with diameters ranging from 1.2m to 2.3m are spread throughout both branches of Warnham Court Road. There is an additional soakaway at the intersection between Warnham Court Road and Stanley Park Road. Four soakaways with a 2m diameter are located along Sussex Road. For further information on soakaways in the local area, see

Figure 8-2. Surface water sewer network and soakaways – Stanley Park Road and Warnham Park Road

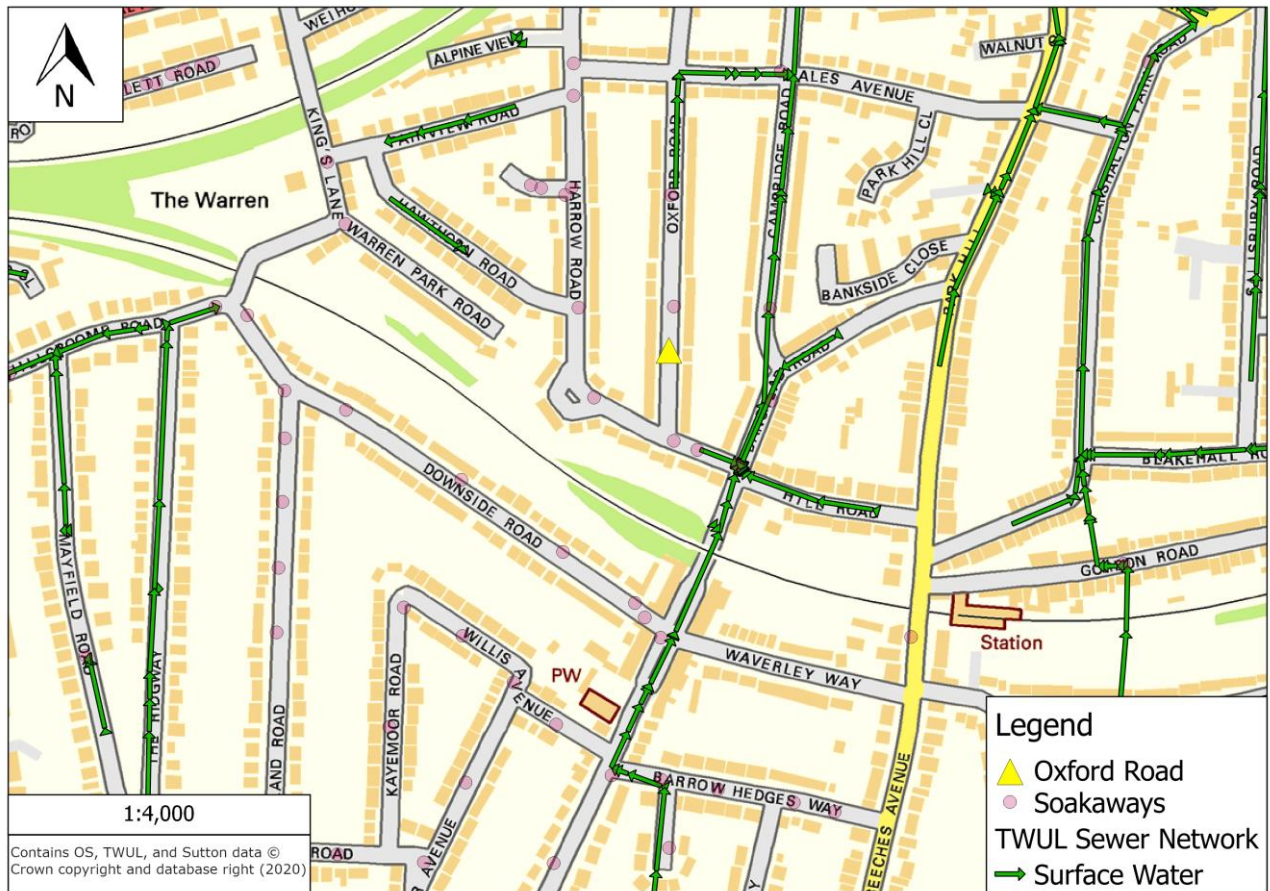
Figure 9-2. Surface water sewer network and soakaways – Oxford Road

There are two concrete lined soakaways that lie along Oxford Road. The southernmost soakaway is 6.2m deep and the northernmost soakaway is 2.9m deep. The condition of both soakaways has been labelled as ‘very good’. Details of the location of soakaways in the local area are shown in
